## JOHN M. BETHEA STATE FOREST (Baker County)

### **Wetland Restoration Needs Assessment –**

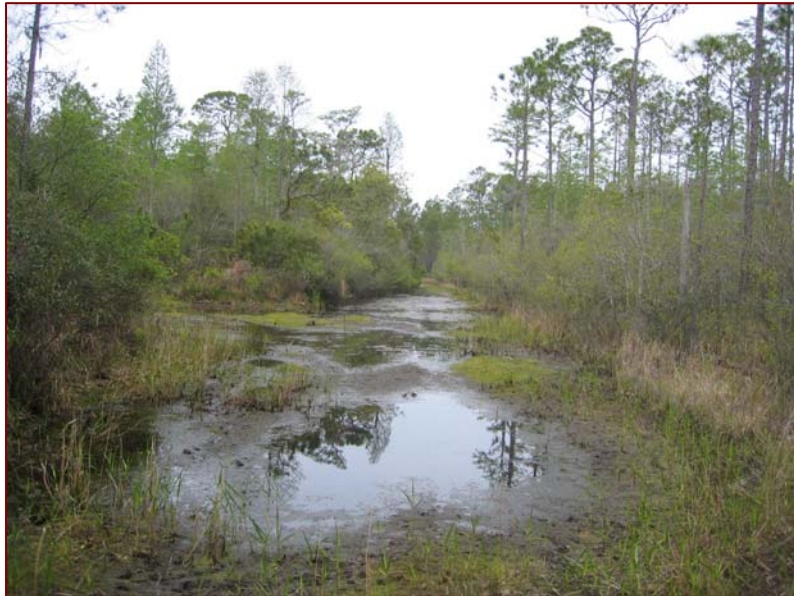
**JMBSF Figure 1:** Old Fireline in wetland, trapping and diverting surface flow near the north forest boundary line.

In 2005, in response to concerns of an adjacent landowner, the John Bethea State Forest (JMBSF) management team installed earthen ditch plugs on old firelines and re-located several culverts on Road 21 and others to restore natural sheet flow towards the St. Mary's River in the northeastern part of the forest.

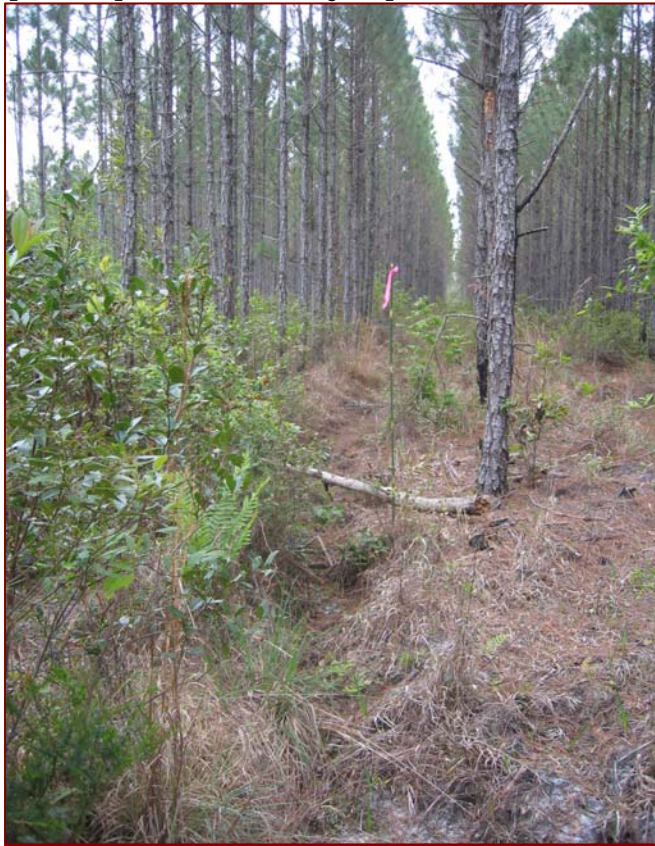
1. Several areas of the forest have been protected by a fireline construction technique referred to as “potato patching”, in which narrow firelines are established between planted rows within a pine stand. Oftentimes these plowlines are connected to road ditches or other plowlines which increases the potential of accelerating surface drainage from an area, or diverting it away from wetlands to which it would naturally flow (**see Figure 2**). As a result of the post “Bugaboo” fire assessment DOF is in the process of rehabilitating these areas
2. The few areas on JMBSF identified as **basin marshes** in FNAI’s Historic Community Type Inventory have been altered as a result of intensive forest management practices on the property in the past. The DOF is interested in restoring as many of these areas to their natural state as possible.

**JMBSF Figure 2:** “Potato Patching” firelines in pine stands on JMBSF sometimes tie into road ditches, which may result in accelerated surface drainage of some areas on the forest.
