JENNINGS STATE FOREST (Clay County)

Previous Restoration Activities -

Wetland Restoration Needs Assessment –

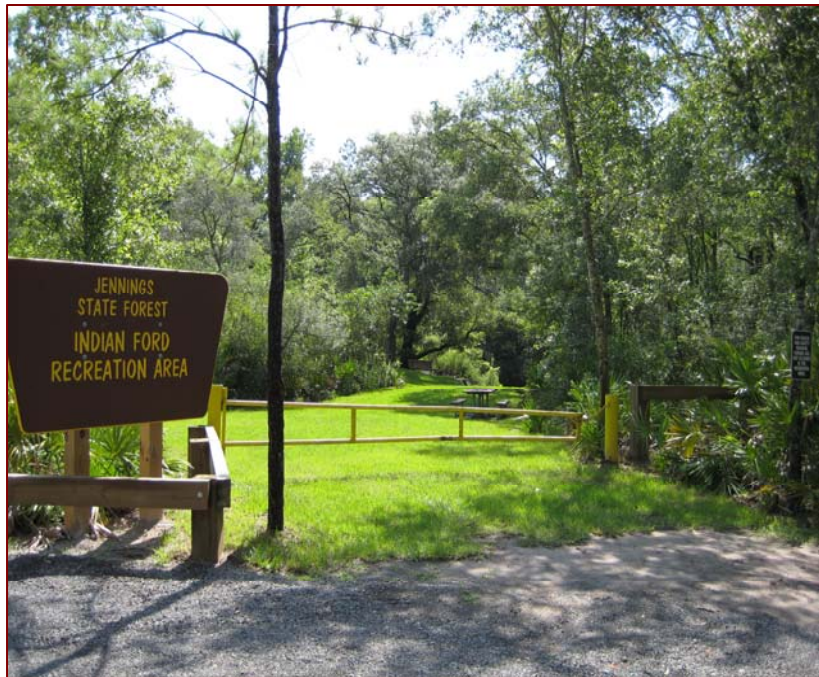
JSF Figure 1: Restored parking area and canoe launch area at the Indian Ford Recreation Site

The Indian Ford road required the placement of a 24” culvert to facilitate cross-drainage just below the parking area and canoe launch approach (**see Figure 1**). To appreciate the extent of erosion that had taken place at the Indian Ford approach, up to four feet of back-fill was needed to bring the road up to grade in places. Once the road work was

completed, guardrails and traffic control structures were placed at each parking and launch area to reduce site degradation in the future.
