LAKE TALQUIN STATE FOREST (Gadsden/Leon/Liberty/Wakulla Counties)

Previous Restoration Activities -

Wetland Restoration Needs Assessment –

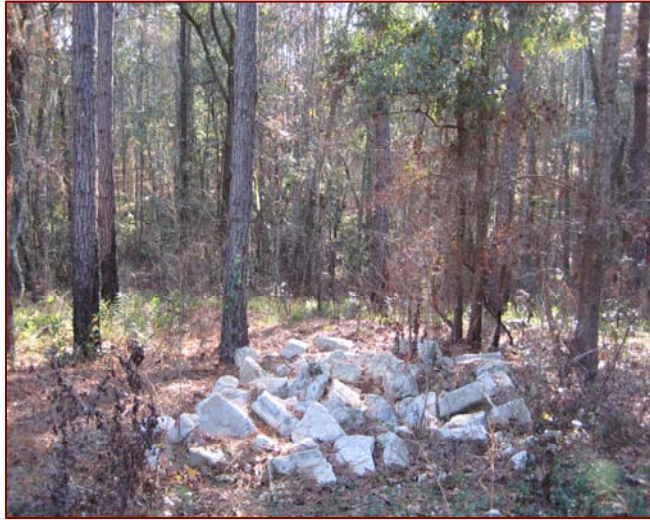
LTSF Figure 1: Rip-Rap “Apron” placed beside a dip in a service road at the top of a ravine on Rocky Comfort Tract. These structures are placed to protect against erosion and sedimentation into bottomland wetlands.

More recently low-water crossings and rip-rap aprons have been installed on some service roads on the Rocky Comfort Tract by the Florida Fish & Wildlife Conservation Commission (FFWCC), which is co-manager of the tract with DOF (**see Figure 1**).

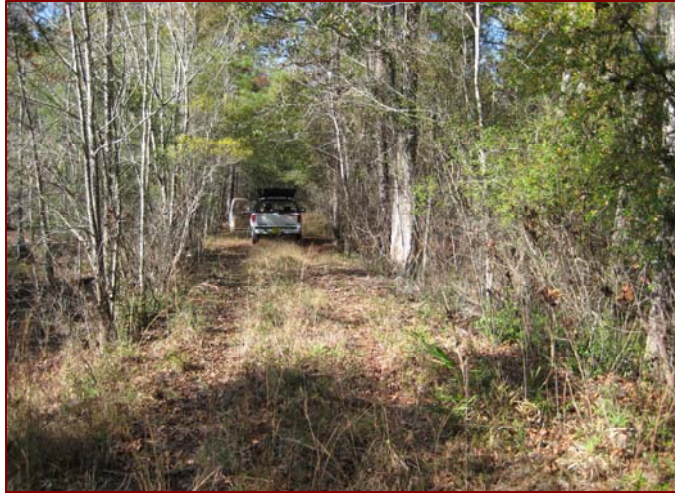
LTSF Figure 2: Above-grade woods road divides a natural drainage on the Searcy Tract. Installation of a culvert or low-water

1. Land features include terraces that were constructed prior to state ownership to prevent soil erosion and sediment discharge into drainages.
2. Much of the eastern tract is comprised of cut-over upland and flatwoods that had been used for pastureland and left open. The western side of the tract is predominantly cypress-hardwood floodplain associated with the Ochlockonee River. The intermittent tributaries which drain the eastern part of the tract appear to be intact and functional.
3. There are at least two places on the tract where surface flow is impeded or re-directed from its natural pattern where low water crossings would enhance the wetland function (**see Figure 2**).
