LITTLE-BIG ECON STATE FOREST (Seminole County)

Wetland Restoration Needs Assessment –

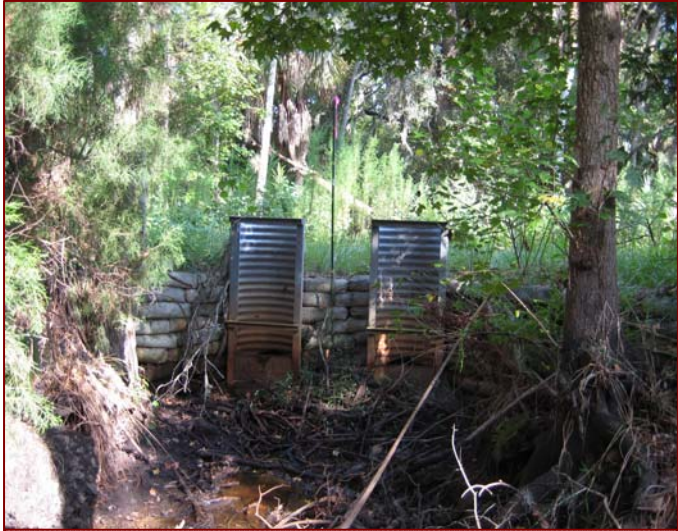
LBESF Figure 1: Flashboard risers installed as part of the SR 434 Mitigation Project on the Demetree Tract. At the time of the photograph conditions on the forest were very dry.

The **State Road 434 Project** was funded through FDOT mitigation to offset wetland impacts caused by expansion work done on SR 434 in 2000. The project involved installing a ditch plug with a flashboard riser (**see Figure 1**) to restore the hydroperiod in a 17-acre area that was drained by a ditch connecting to the Econlockhatchee River. The project footprint was stabilized by constructing a retaining wall and seeding in grass.

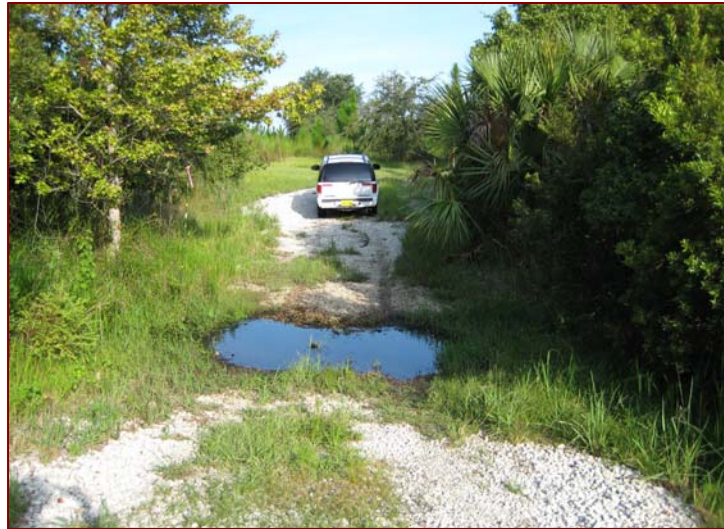
LBESF Figure 2: Low-water hard-surface crossing on the Demetree Tract. Surface flow through this crossing leads to the Econlockhatchee River.

1. Over the years the LBESF management team has installed low water hard-surface crossings (**see Figure 2**) on most of the service roads over existing ditches, using geo-fabric, webbing, and limerock to stabilize the bottoms and approaches, some of which are fairly steep (20%+). Several crossings are in need of repair or replacement.

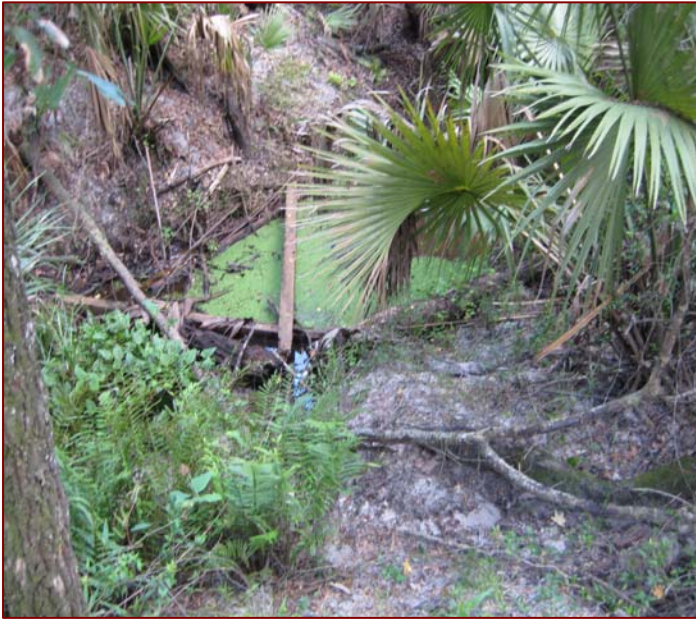
4. The **Spencer-Leeper Ditch**, extending about a mile from the old celery fields on the southern end of the forest discharges into the Econ River. The ditch averages about 10 feet deep, with the spoil banks extending another 10 to 20 feet above normal ground elevation. The banks have become popular bike/ hiking trails. Footbridges and armored trail sections allow passage over tributaries to the ditch and pose no immediate threat to the integrity of the artificial drainage. Although limited opportunities exist for restoration involving the ditch

LBESF Figure 3: Spencer-Leeper ditch, which drains into the Econ River, shows signs of degradation and over-use from the bicycle and hiking trails on its berms. Erosion and sedimentation is impacting the flow in the ditch at places.

exist since it has been in existence so long, some work needs to be done to stabilize eroded sections of the trails on top of the berms to protect water quality (**see Figure 3**).
