MATANZAS STATE FOREST (St. Johns County)

Current/Planned/Proposed Restoration Activities –

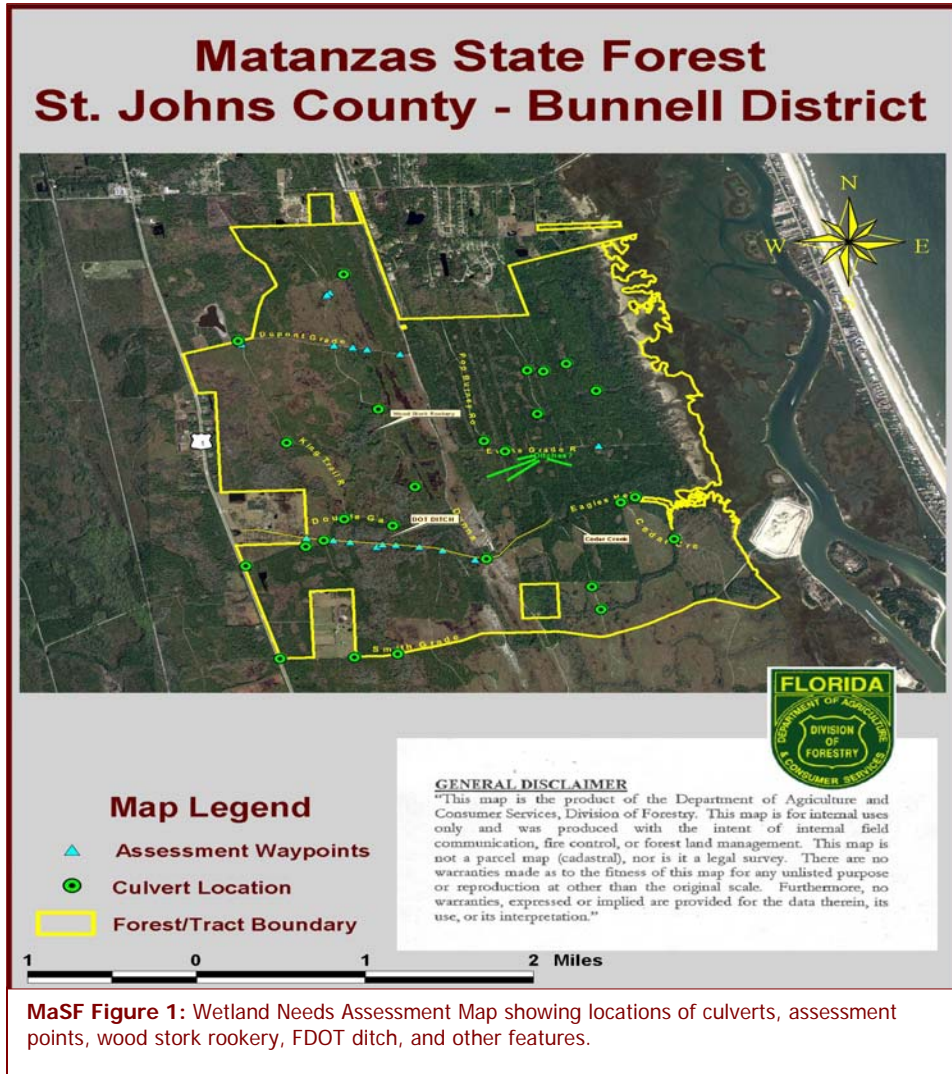
Additionally, hydrological and plant community restoration opportunities may exist involving a **DOT Drainage Ditch** that has become over-grown with woody tree and shrub species (see **Figure 1**). The ditch traverses over 1.5 miles from US Hwy 1 across the forest to Cedar Creek which ultimately drains into the Inter-coastal Waterway on the east coast. Comparing current aerial photographs with historical aeriels of the site, it appears that the ditch, at least to some extent, interrupts the natural surface drainage from the northern part of the forest where the wood stork rookery is. Consequently, consultation with the FDOT, DEP, SJRWMD, and FFWCC will be necessary before moving forward with any restoration work on the structure or this part of the forest.

Currently one project opportunity involving exotic plant assessment and control is listed on the *FERI* website for MaSF. However, other project opportunities exist, particularly for wetland enhancement, involving the replacement of damaged or inadequate culverts on several of the primary forest service roads. For example, a single, 36-inch metal culvert on the Smith Grade Road that crosses a basin swamp on the southern boundary of the MaSF is inadequate to convey the volume of water draining from the wetland during storm events. Replacement of this culvert with multiple culverts and a flashboard riser that can be adjusted according to water levels in the wetland would greatly enhance the hydrological function of the wetland.
