CARY STATE FOREST (Duval/Nassau Counties)

Wetland Restoration Needs Assessment -

An assessment of the **Monticello Tract** (3,942 ac.) was completed in July, 2007. The following observations made during the assessment are among the assessment findings. Additional information about the assessment is available upon request from the Division of Forestry.

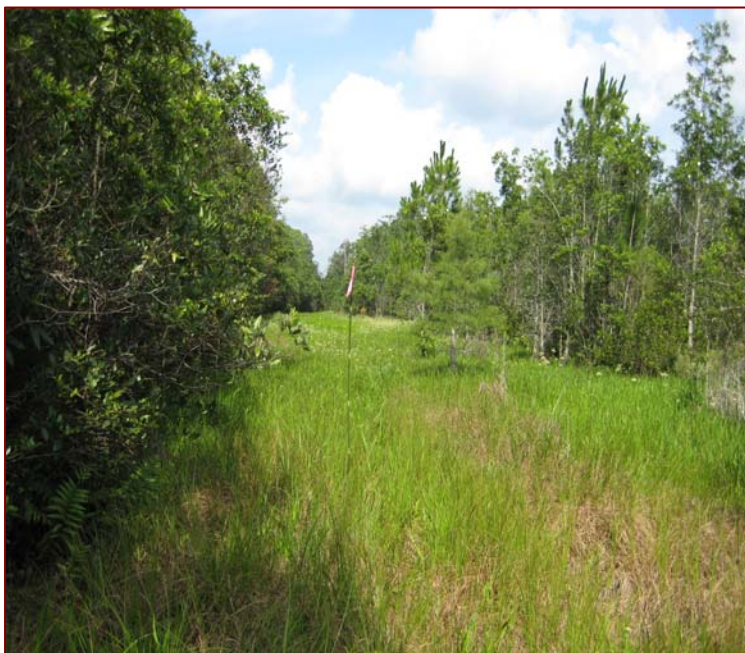
CSF Figure 1: “No Catch Swamp” fireline, 20 years later, showing herbaceous vegetation recovery; shrub and trees on berm on left.

A major restoration project would be the 30-ft wide “No Catch Swamp Fire” fireline located south of the swamp. The fireline, constructed in the 1980s, still scars the bay swamp and has only slowly recovered with wetland herbaceous vegetation in that period of time. The southern berm of the fireline, while stabilized by wetland hardwoods that have become re-established, inhibits natural (sheetflow) drainage to some extent and may need to be modified in some way to restore site hydrology.

Although there are no formally developed active projects on the forest, the Cary State Forest management team is installing two (2) 24-inch plastic culverts on the road across “No Catch Swamp” on the Monticello Tract. These culverts, replacing 1 undersized collapsed culvert, should greatly equalize drainage flow within the swamp. Also related to the “No Catch Swamp”, discussions have occurred pertaining to the restoration of the No Catch Swamp fireline that was constructed over 20 years ago (see **Figure 1**). However, as of this writing, no formal restoration plan has been developed.
